FAULT CODE L2 – (Alternating ‘L’ & ‘2’ – Ignition lock out)

Introduction

There are external factors to the GB24 and GB30 boiler which cause the L2 Fault Code to display and switch the boiler off. This factsheet describes what the external factors are and how an end user can resolve them and restart the boiler.

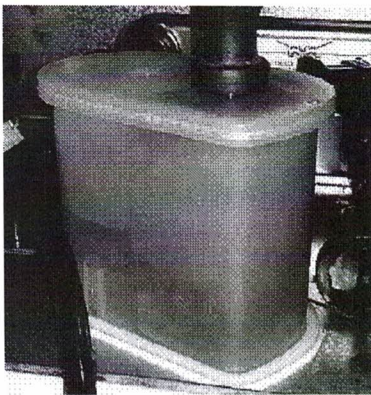
This extinguishes the burner in the boiler and displays a fault code of L2. If your condensate trap looks like the picture below to the left, not like the clean one to the right and / or is making a gurgling noise then there is a strong possibility that this is your problem.

Dirty / blocked condensate trap

This problem is not covered under our warranty as we are unable to control the cleanliness of air entering the boiler and the volume of condensate by-product being produced. Our manual advises that the boiler should be serviced at least annually. The frequency of servicing will depend upon the installation condition and usage. During a service the engineer, amongst other things, will remove the burner and clean the whole heat exchanger and condensate path with hot water. This returns the system to a clean state. This is the best guard against a blocked condensate system. It is important to use a Gas Safe Engineer to carry out the service.

To reset boiler, turn the mode control knob (far left hand side on the boiler) to the reset position and immediately turn knob back to required setting. The boiler will repeat the ignition sequence if a heat demand is present. If the boiler still fails to light consult a Gas Safe Registered Engineer, or in other countries a qualified and competent Gas Installer.

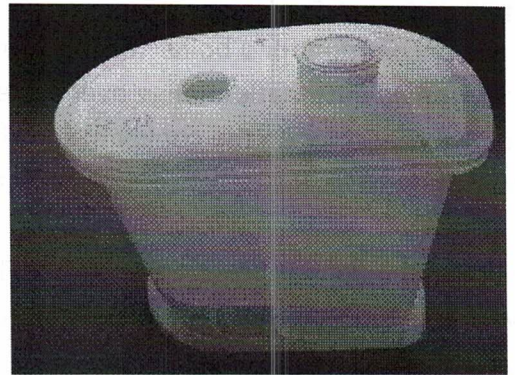
Both the GB24 and GB30 are condensing boilers. In common with all condensing boilers, whilst the boiler is in use a condensate liquid is produced that leaves the boiler via a syphonic condensate trap (as can be seen in the right hand picture) and flows into the waste water drain under the holiday home. In certain circumstances the pathway leading to the condensate trap can become blocked as well as the condensate trap itself. An indication of this occurring is when a gurgling noise is produced from the boiler and the condensate trap becomes discoloured and black.

Clean condensate trap

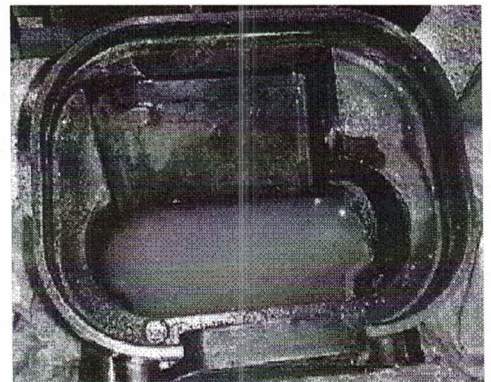
Blockages occur because debris that the boiler breathes in via the flue and the condensate fluid by-product becomes stuck within the pathway leading to the condensate trap. This in turn also blocks the waste pipe and trap. Therefore the boiler cannot remove the condensate liquid and fails to operate which shows fault code L2. The image to the right shows an example of liquid building up from the trap back into the boiler. This may occur more frequently to boilers that are exposed to slightly harsher environments such as salt, sand, dust and leaves from trees.
